NEW BUSINESS – DWELLING IN TRANSIT

Application: Land Use, Dwelling in Transit

File Number: 4770

Address of Inspection: 29276 Patriot Ave

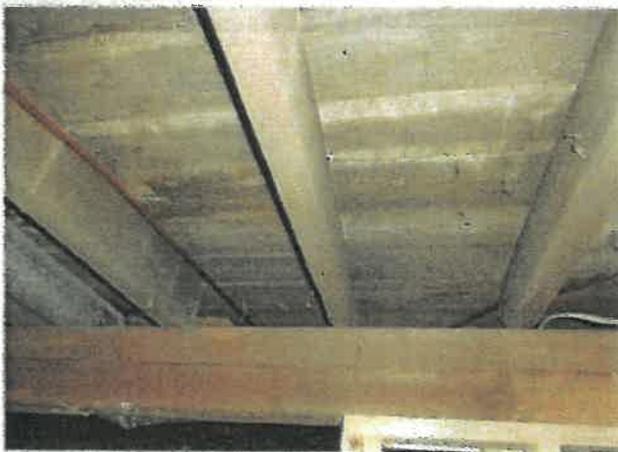
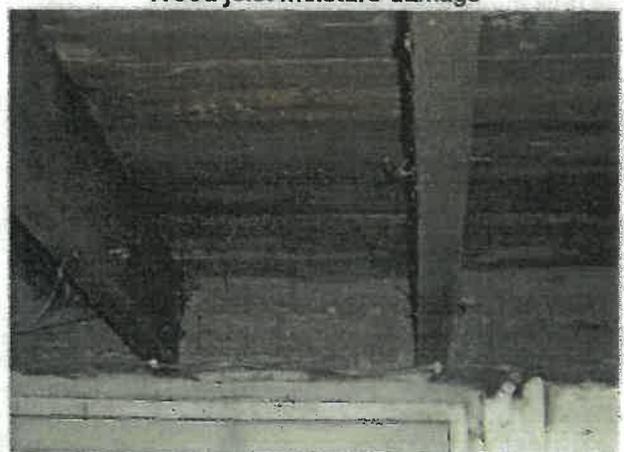
Wood joist moisture damage

There is moisture damage/soft wood conditions on some areas of the sub-floor wood joists and sill plate. The entire sub-floor structure should be fully evaluated by a general building contractor on-site prior to the expiration of your home inspection contingency period and they are responsible for identifying all sub-floor repairs necessary.

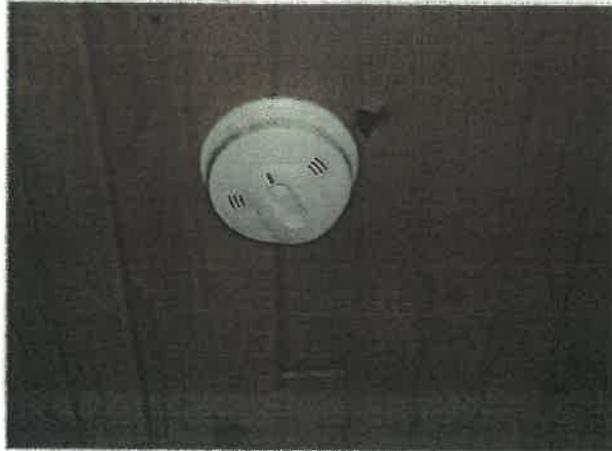
There were no carbon monoxide detectors found in the home. Carbon monoxide detectors should be installed within ten feet of all bedrooms.

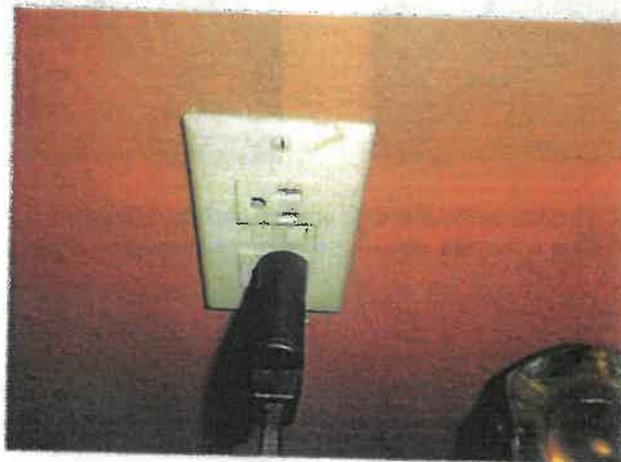
The kitchen outlet on the right kitchen wall were tested with an electrical tester and are not on a GFCI circuit. GFCI outlets are recommended within six feet of all water sources but are not required.

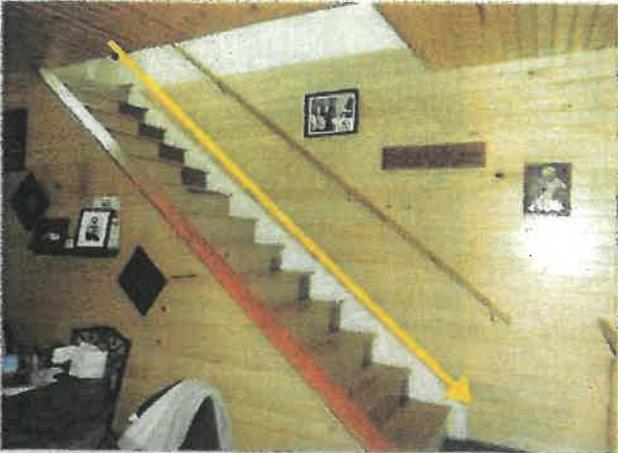
Open staircase is potential fall concern for small children

The open side of the second level staircase without a side wall or vertical balusters is a potential safety concern for small children falling. Consider installing a framed plywood or sheetrock wall or install a railing with vertical balusters.
