NEW BUSINESS – DWELLING IN TRANSIT

Application: Land Use, Dwelling in Transit

File Number: 4770

Address of Inspection: 29276 Patriot Ave

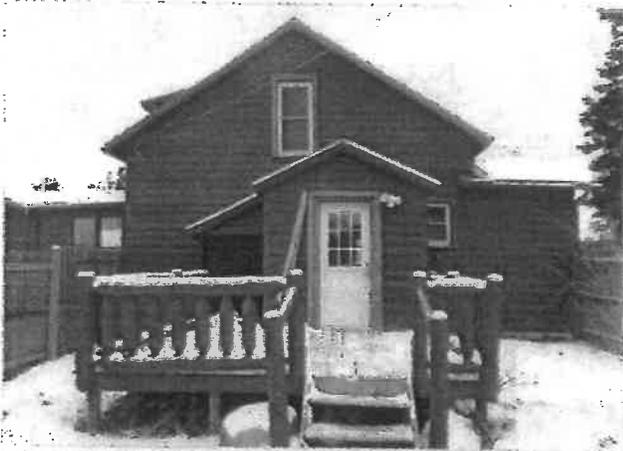
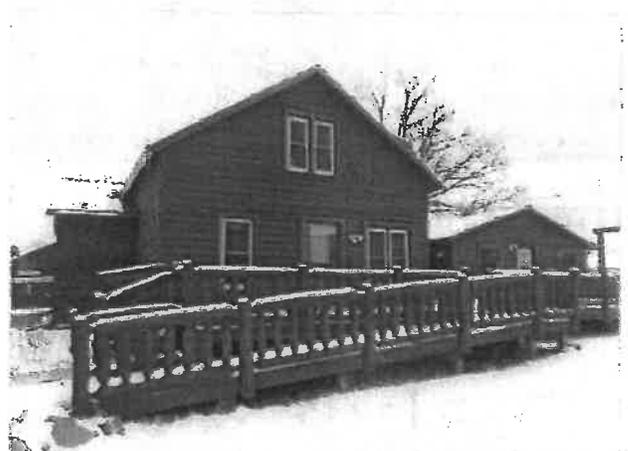
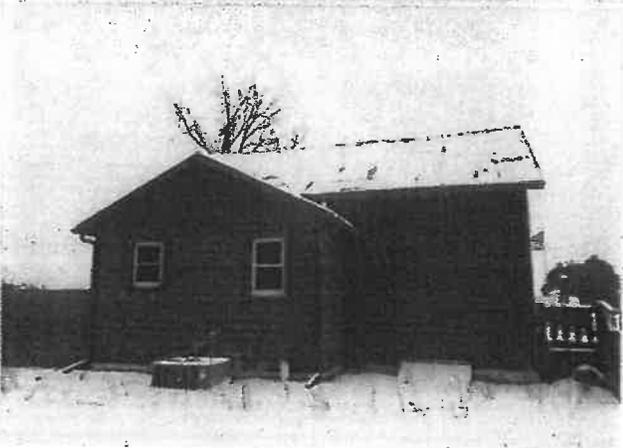
The inspected property consisted of a single family, wood framed structure with wood siding that was occupied at the time of the inspection. There were no major defects on the exterior.

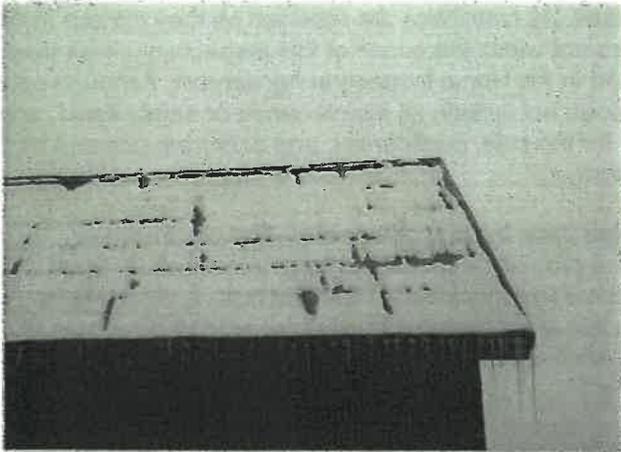
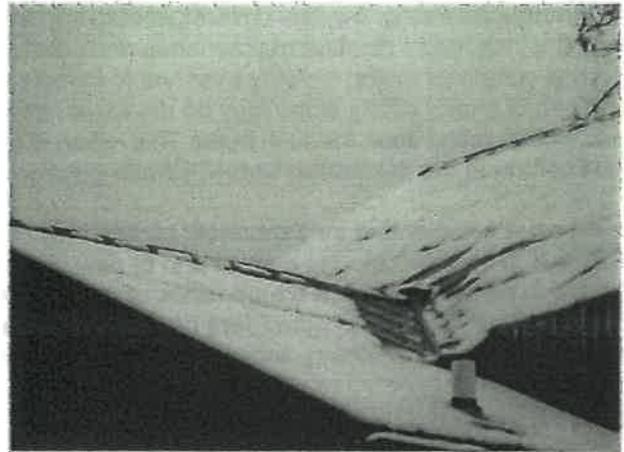
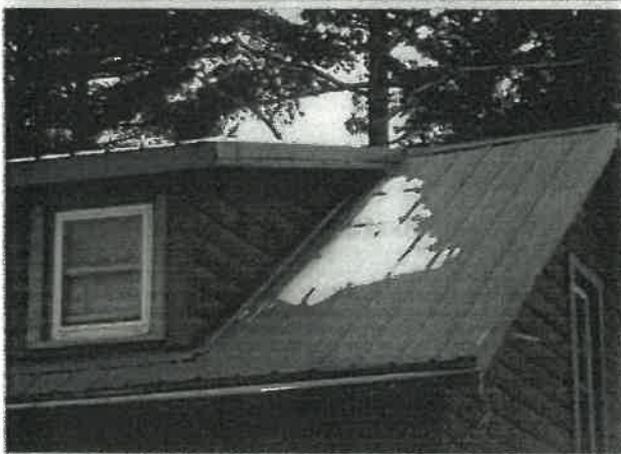
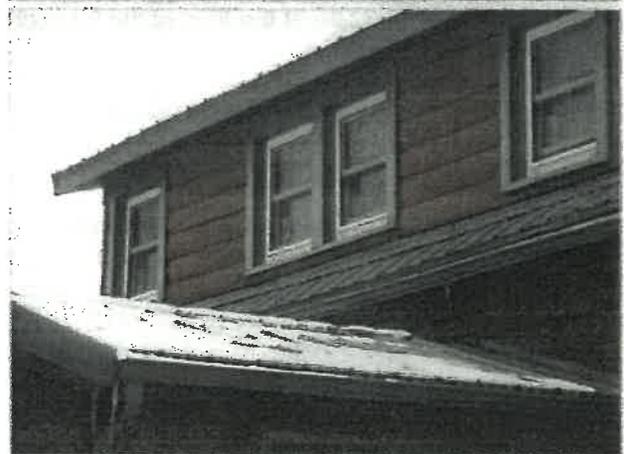
The roof was mostly covered with snow so the roof could not be inspected and is excluded in this inspection. There were no interior visible signs of active roof leaks at the time of the inspection.

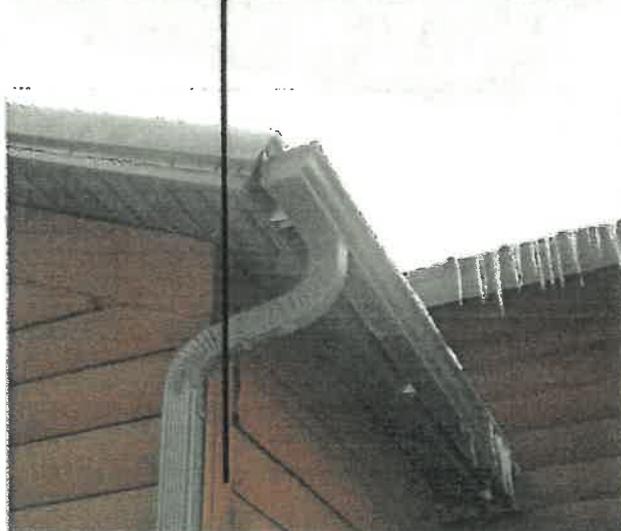
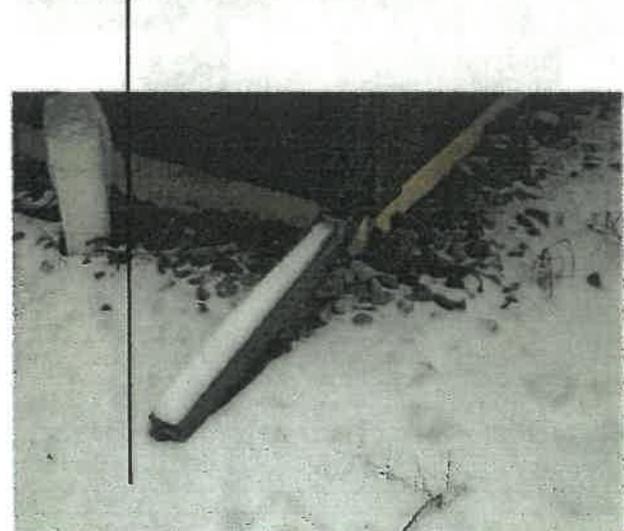
The roof drainage system consisted of aluminum gutters and downspouts. We highly recommend that all downspouts should have six foot ground level extensions installed to route water away from the foundation.

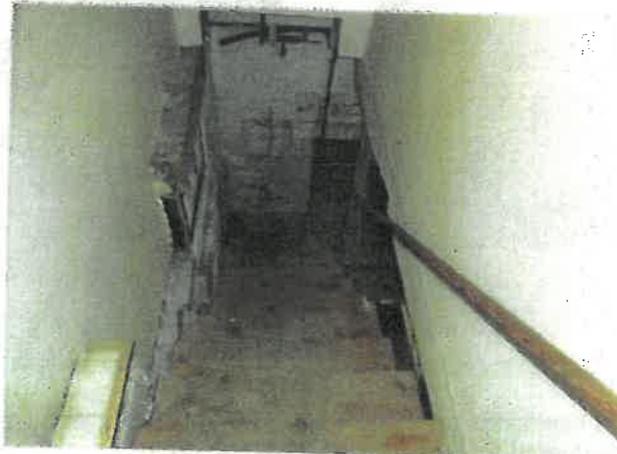
The full basement was mostly finished and contained the following mechanical systems: furnace and water heater. The basement level consists of a utility room and storage. The basement was dry at the time of the inspection.

There were no active moisture stains on the floors and walls. We cannot predict future moisture intrusion, we are only required to report on the condition of the basement at the time of the inspection. If significant moisture intrusion occurs in the future, the installation of a drain system and/or sump pump(s) may be necessary.

Because the basement is below grade, there exists a vulnerability to moisture penetration after heavy rains or spring thaws (this may cause deterioration and/or mold). We recommend the continuous use of a dehumidifier from Spring through late Fall to help maintain a moisture level average of 40%.

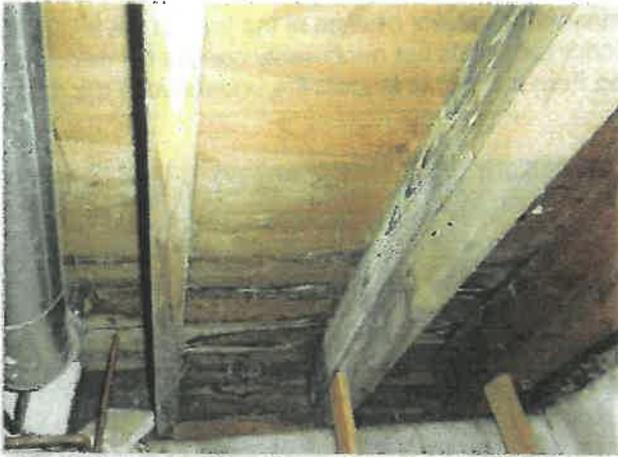
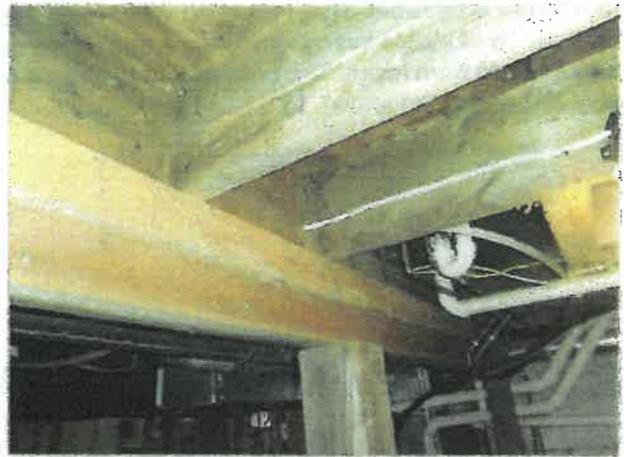
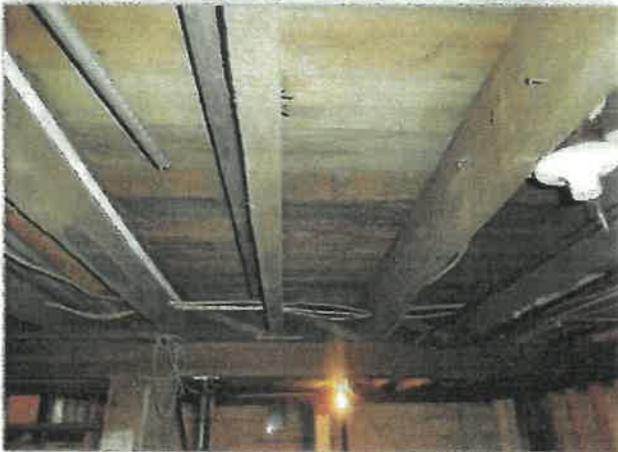
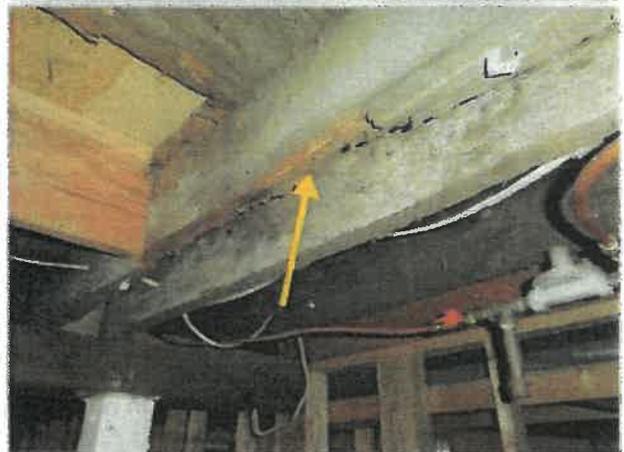
The sub-floor structure was unfinished and fully visible at the time of the inspection.

The visible areas of the floor structure consisted of a wood planking sub-floor supported by two inch by six & eight inch wood joists spaced sixteen inches on center. There were walls for load bearing support.

There were no defects observed in the visible portions of the floor structure.

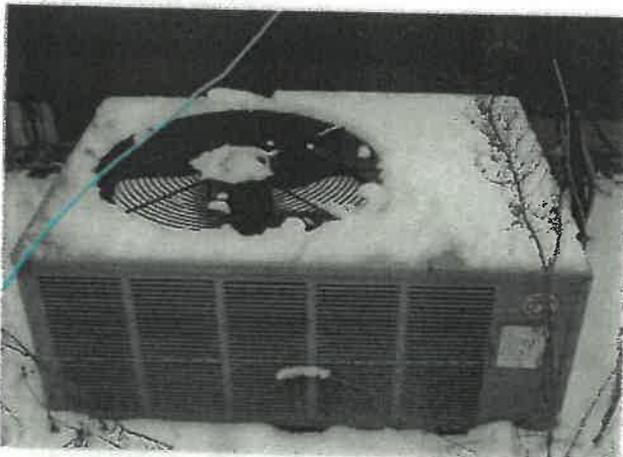
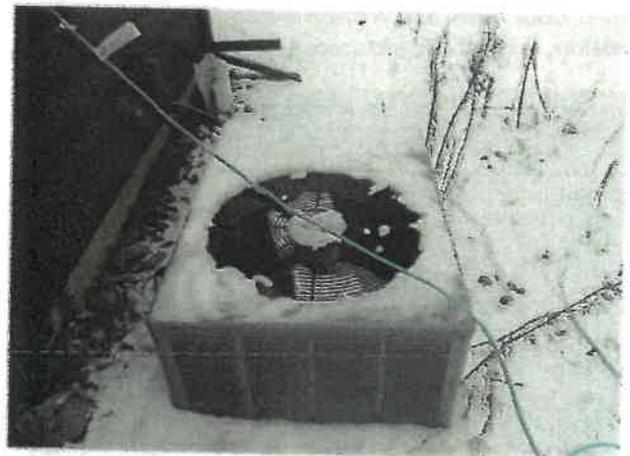
The electric outdoor air conditioner condensing unit was a Rheem, model number RAND-030JAZ and serial number 7294 M4907 08195. The unit is located on the left side of the home. This unit is approximately 11 years old.

The air conditioning system was not tested due to outdoor air temperatures below 45 degrees Fahrenheit. If A/C condensing units are cycled when temperatures are below 45 degrees Fahrenheit the compressor can be damaged. You may request that the current homeowner provide a purchase contract addendum letter to you stating that the A/C system is fully functional.

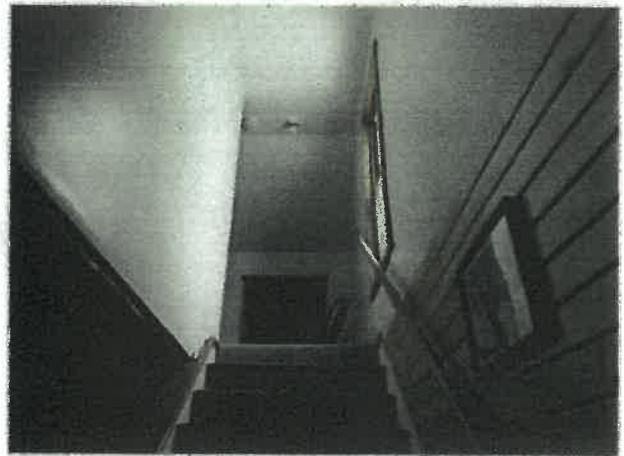
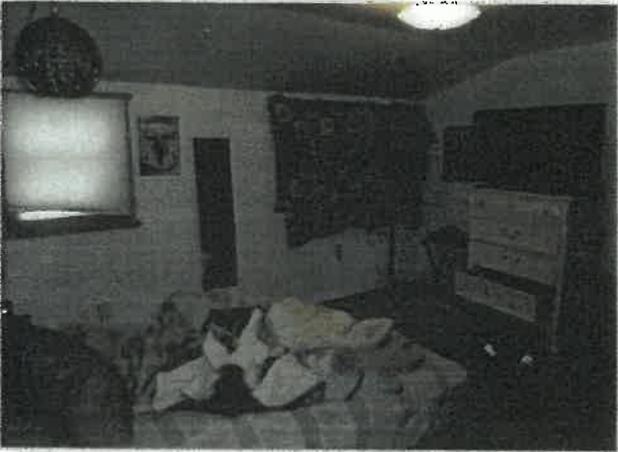
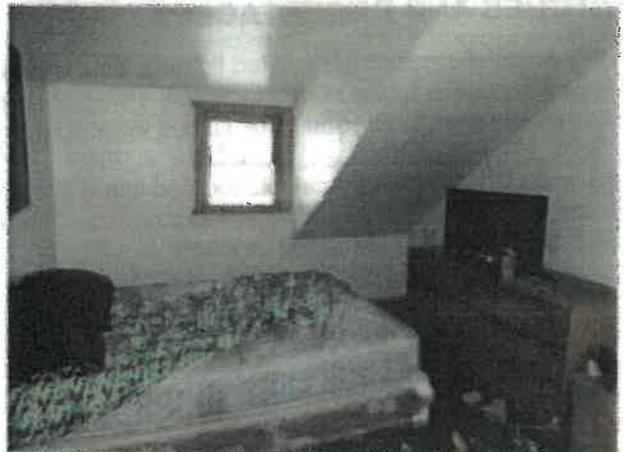
Open staircase is potential fall concern for small children

The open side of the second level staircase without a side wall or vertical balusters is a potential safety concern for small children falling. Consider installing a framed plywood or sheetrock wall or install a railing with vertical balusters.

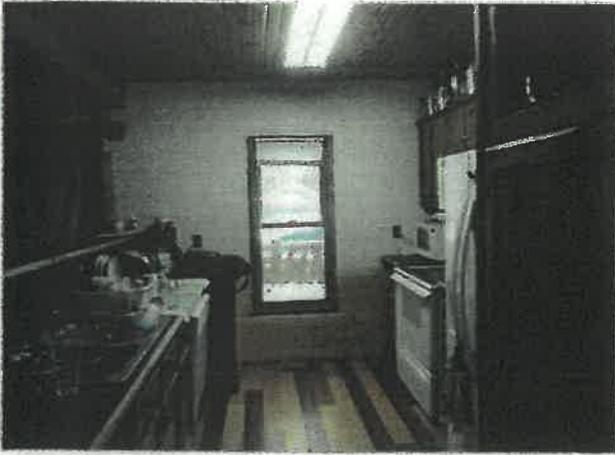
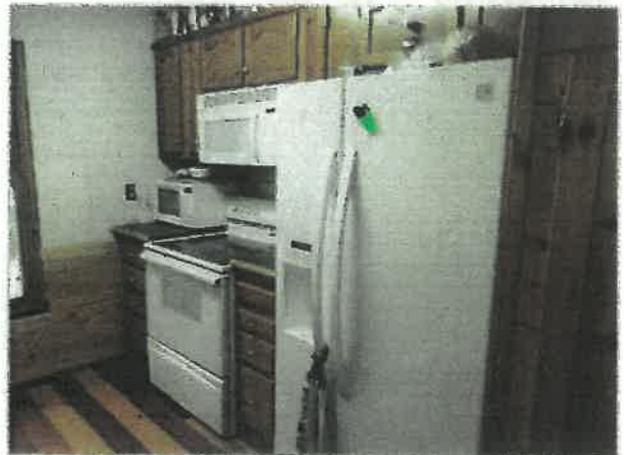
OVEN RANGE

The Admiral electric free standing range was tested and is functional. The accuracy of the heat settings are not within the scope of this inspection.
